## THE NEW AQUARIUM AND NEW SEA-WATER CIRCULATION SYSTEMS AT THE PLYMOUTH LABORATORY

By DOUGLAS P. WILSON, D.Sc.

The Plymouth Laboratory

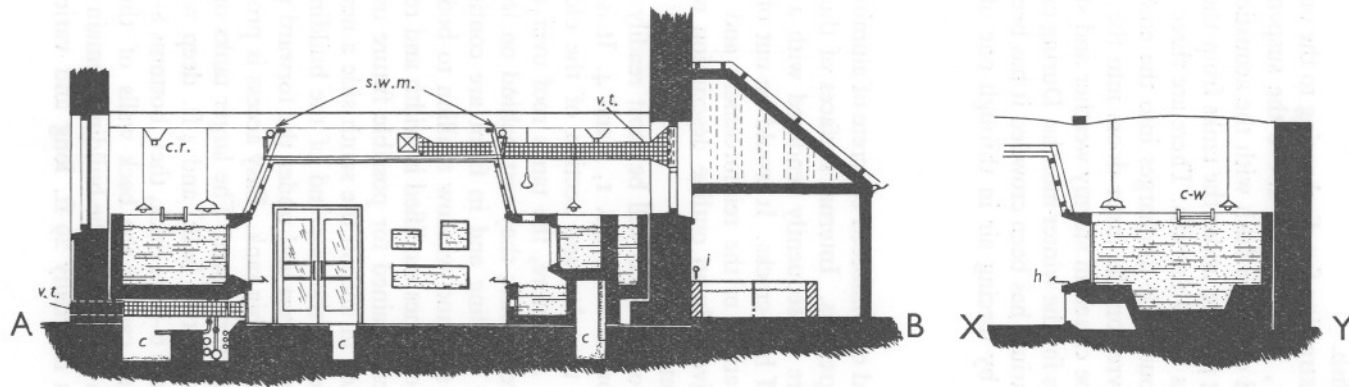
Fig. 2

Text-figs. 1 and 2. Plan and sections of the new aquarium and new outside circulation. Water in the exhibition tanks is indicated by line and dot stippling. *c*, sea-water return culvert; *c.b.*, circulation bench; *c.r.*, overhead conveyor rail (Henderson track); *c-w*, cat-walk; *h*, hand-rail; *i*, inflows; *o*, overflows; *p.b.*, plunger bucket; *s*, sill; *s-w*, swim-ways; *s.w.m.*, sea-water main.

The hall is ventilated by an extraction fan discharging to the outside at the north-west corner (Text-figs. 1, 2). Trunking above the suspended ceiling draws air through three louvred openings flush with the acoustic tiling. Air enters the hall through trunking passing under the tanks from the outside of the building to louvred openings below the sills. There are three such trunks on each side, but one on the south side discharges into the emergency exit passage, and then through louvres on the inner doors into the public hall. Louvres on the south side can be closed in stormy weather and storm covers are fitted on the outside openings for the winter months. During exceptionally hot calm weather when the aquarium has been crowded it has been necessary to augment normal ventilation by forcing air in through one of the intake trunks on the north side.

The arrangement and shapes of the tanks will be most readily understood by a study of the plan and sections in Text-figs. 1, 2 and 4. It is instructive to compare these figures with the plan and section of the old aquarium (Wilson, 1952, text-figs. 1, 2). As before, the tanks roof over culverts returning overflow water to the reservoirs; they rest behind on ledges at the bases of the main walls of the building and in front are continuous with concrete pillars extending each stile and window mullion to bedrock below floor level. The culverts are the old ones modified in width and re-asphalted. The old central culvert has been retained for possible future use. The old drainage trenches have been filled in and on the south side a new trench to carry services to the laboratories at the east end of the building has been excavated alongside the southern culvert and under the forward parts of the tanks. These services pass under the big tank. Easy access is provided to all culverts and to the service pipes everywhere. The larger tanks on the north and south sides are 6 ft. wide (front to back) and 4 ft. deep with a water depth of 3 ft. 6 in. Their walls are 6-7 in. thick, their bottoms 8-9 in. thick. Creosoted soft-boards used when casting the back walls of the tanks, to prevent the concrete adhering to the walls of the building, remain in position. The big tank at the east end is internally 29 ft. long and varies in width

In the north-west service area (Text-fig. 1) a number of small asbestos tanks are used to store live food (shrimps, crabs, mysids, worms, etc.) and to accommodate recently caught small animals until such time as they are placed in the exhibition tanks. This corner also houses the 'plunger-bucket' (to work 'plunger-jars' in a laboratory above) which is supplied with water from the north-side series of tanks.

Under a new roof a new series of outside tanks was used for the first time in September 1957. They comprise (Text-fig. 1 and Pl. II, fig. 2) three blocks of concrete tanks (painted internally with bituminous paint) and nine large (100 gallon) and four small (20 gallon) asbestos tanks on raised plinths (Text-fig. 1). A double tier of slate shelving, built partly against the main building and partly against a wall at right angles to it, forms a circulation unit for bowls and jars. Four of the concrete tanks are divisible by asbestos sheets sliding in grooves; a fifth is bowl-shaped to accommodate squid and cuttlefishes. The water depth of the smaller concrete tanks is roughly 19 in., while the water depth of the large central tank can be varied at will at 23, 31 and 36 in. by placing rubber bungs in the lower overflow holes. All overflow pipes pass down inside the thickness of the tank walls and are fitted with plastic bowl-shaped sieves ('salad-shakers' from a local store) to prevent the ingress of large objects. These overflows discharge into a culvert below ground level which returns overflow water to the reservoirs. The culvert and the lower ends of all overflow pipes are readily accessible through a series of manholes. Inflow pipes are also within the thickness of the walls and discharge into the tanks close to the bottom.

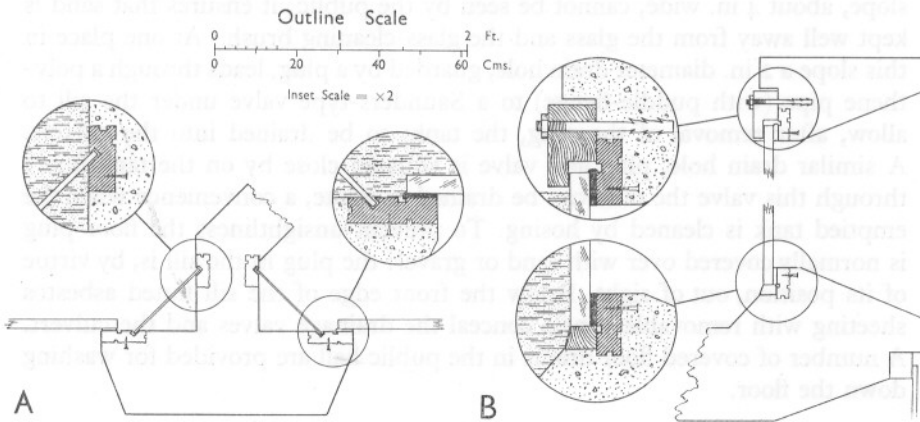
Text-fig. 3. A. Plan of a stile between a triangular tank on the right and a larger tank on the left, including a portion of the dividing wall with polythene sheets slid into slate slots to form inflow ducts. Inset are details of slotted slate inserts keyed to the concrete by grooving and rustless-steel screws. In the right inset is shown the edge of a glass pane with sealing compound ('Glasticon', drawn solid black) between it and the slate.

B. Section of a tank front showing lintel walk-way and sill. Inset above are details of teak turnbuckle on rustless-steel rag-bolt, top edge of glass, water level, etc. Inset below shows bottom edge of glass resting on teak block on ledge of sill with details of grooved slate inserts, sealing compound, etc.

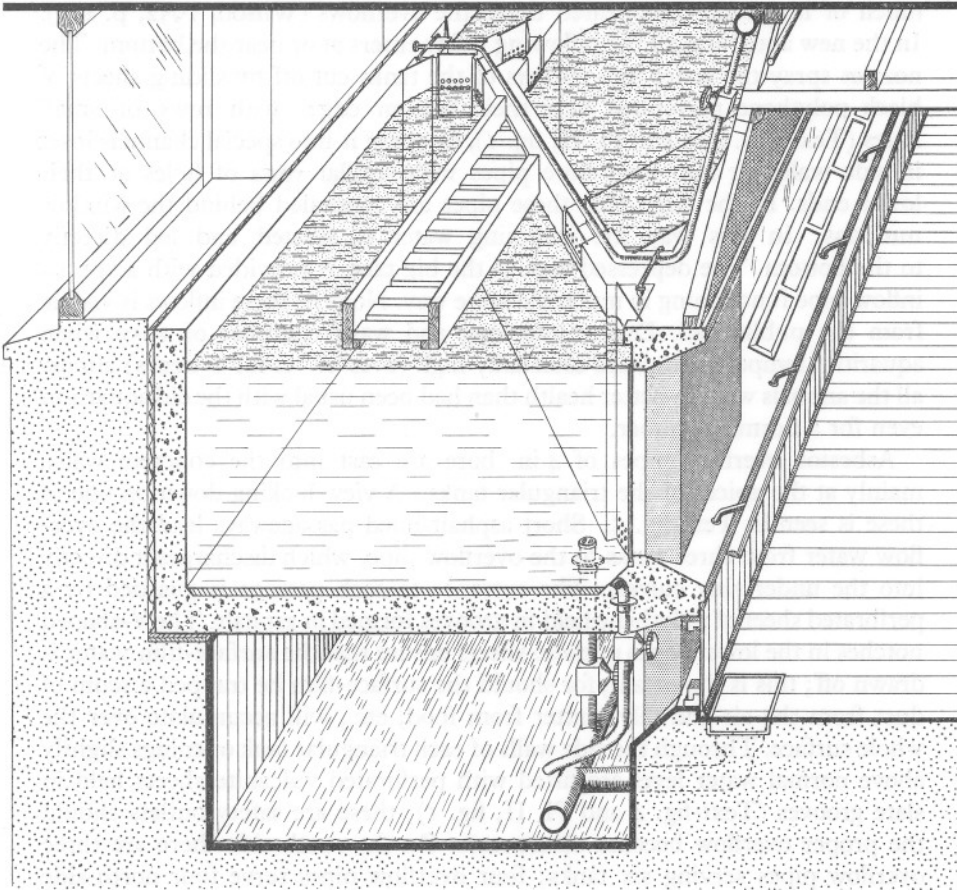
Text-fig. 4. Section through a north-side tank incorporating perspective view facing east and showing portions of three tanks and part of the public hall. Behind the tank is the main wall of the building with a window. The back of the tank rests on a footing of the wall, but indirectly on copper plates forming a sliding bearing to allow for possible movement; the plates are sealed from the sea-water circulation. Between the back wall of the tank and the wall of the building is a layer of creosoted soft-board which during construction prevented the liquid concrete from adhering to the building. Under the tank is an asphalt-lined sea-water return culvert within which is a drain pipe running to waste. From this drain pipe there is a connexion, through a valve, to the tank floor and through an open pipe another branch leads to a covered sump in the public hall. A drain in the tank sill, controlled by a valve, can discharge water into the culvert and so back to the reservoirs. At the apex of the triangular tank there is an overflow serving all three tanks, a swim-way between the two larger tanks, and to the latter an inflow each. These structures are shown in greater detail, viewed from above, in Text-fig. 5. A portion of a cat-walk is shown, and in the wall on the nearside a safety overflow from the triangular tank is seen. Still farther forward are two inflows, one of them to the triangular tank. The polythene branch pipe, with Saunders valve, serving the inflows, leads down from the sea-water main at ceiling level. Nearby is the main compressed-air pipe, but no valves or branch connexions to this are shown. In the public hall are seen the hand-rail with supports inserted in the concrete sill; label frames between it and the glass; and below the sill, fluted asbestos sheeting down to floor level.

A special servicing feature are the 'swim-ways' in the walls between the larger tanks (see especially Text-figs. 4, 5). These openings (approximately 1 ft. wide, extending below the water level for about a foot) are normally closed each by two sheets of black polythene slid into grooves; the sheets are perforated above water level to allow of their functioning as additional safety overflows. These openings, once the sheets are removed, permit fish to be swum from one tank to another as desired. Thus during a major tank-cleaning operation the fish of one tank will be netted and removed to storage tanks in the yard, choosing for netting easily caught and not readily damaged species such as dogfishes and conger eels. The swim-way adjacent having been made watertight (with a bolted-on cover and sealing compound) this tank will be emptied, cleaned and reflooded. The swim-way will then be opened and the

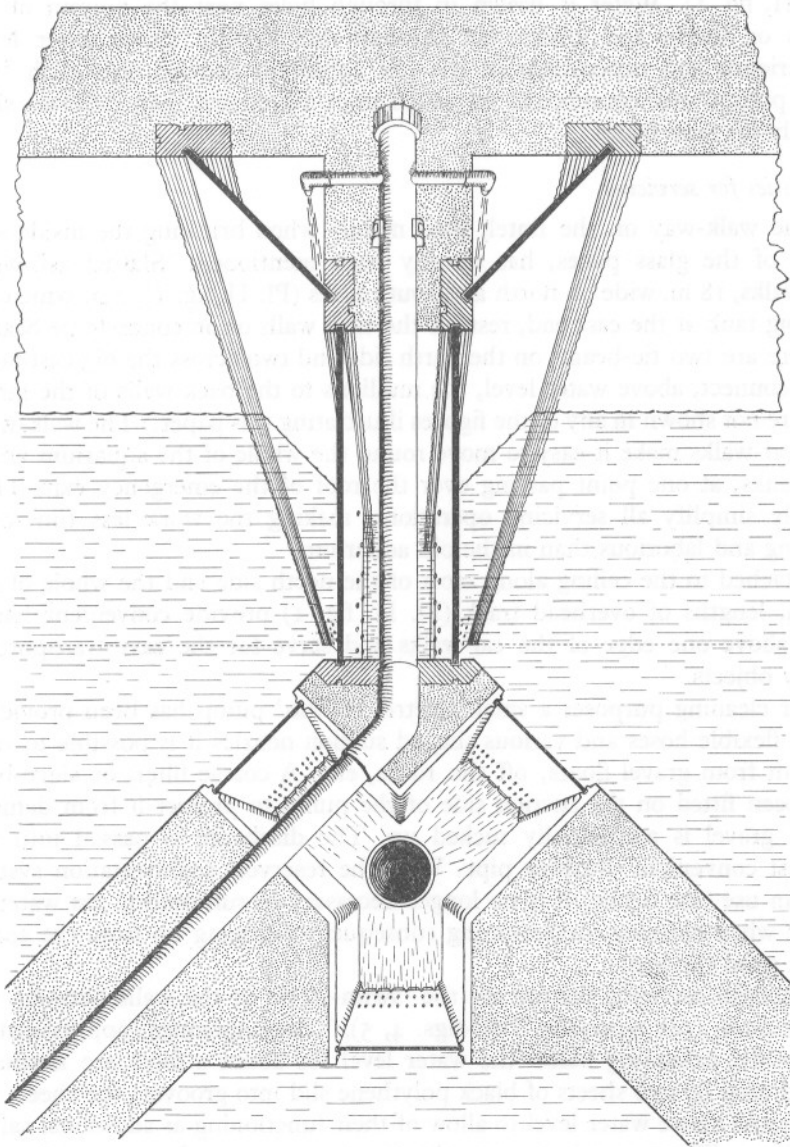
Text-fig. 5. Perspective drawing looking down on an overflow serving three tanks, a swimway between two tanks, and inflows to two tanks. The top faces of the concrete are stippled; of the slate inserts hachured; while the top edges of the sliding polythene sheets are solid black. The top edges of the asphalt lining of the overflow channels are unshaded. Water is shown by dashed lines.

Asbestos overflow pipes of 4 in. bore are cast into the concrete walls, mainly at the apices of the triangular tanks. A view looking down on one of these is seen in Text-fig. 5. Short asphalt-lined passageways lead the overflow water from three tanks to the overflow pipe, which discharges it directly into the underlying culvert. The entrance to each passage is guarded by a perforated sheet of polythene held in grooves formed in asphalt. The V-shaped notches in the lower edges of these sheets ensure that the surface-film water is drawn off; this is important, for should the surface-film be trapped a scum of dust from the air and oily matter from food, etc., will accumulate over the whole surface. Through the side walls of each triangular tank openings slightly above normal water level are fitted with perforated vulcanite sheets held in slate grooves (Text-fig. 4 and Pl. II, fig. 1); these are safety outlets should the proper overflow become obstructed. On the south side there are three overflow pipes serving six tanks; four overflow pipes serve four north-side tanks, the big end tank and the two corner tanks, and all seven tanks can overflow into one another. It is thus impossible for tanks to overflow unless all overflow pipes of a series are simultaneously blocked, which is virtually impossible.

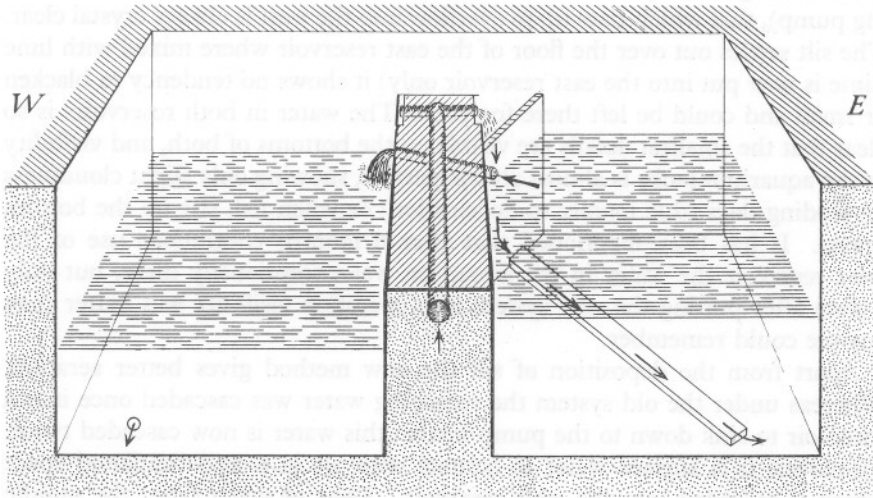
Text-fig. 6. Diagram of the sea-water reservoirs (not to scale and with roof omitted) to show method of circulation now in use. The direction of water flow is indicated by the arrows.

The method now in use involved no more than minor modifications to the existing reservoirs. These are shown diagrammatically in Text-fig. 6. Water returns from the aquarium along a 1 ft. diameter pipe in the wall dividing east and west reservoirs. At its northern end there is a T-junction where sluices divert the water to one or other of the reservoirs as required; in the old days it would be the reservoir from which water was being pumped, there being then no communication between reservoirs.

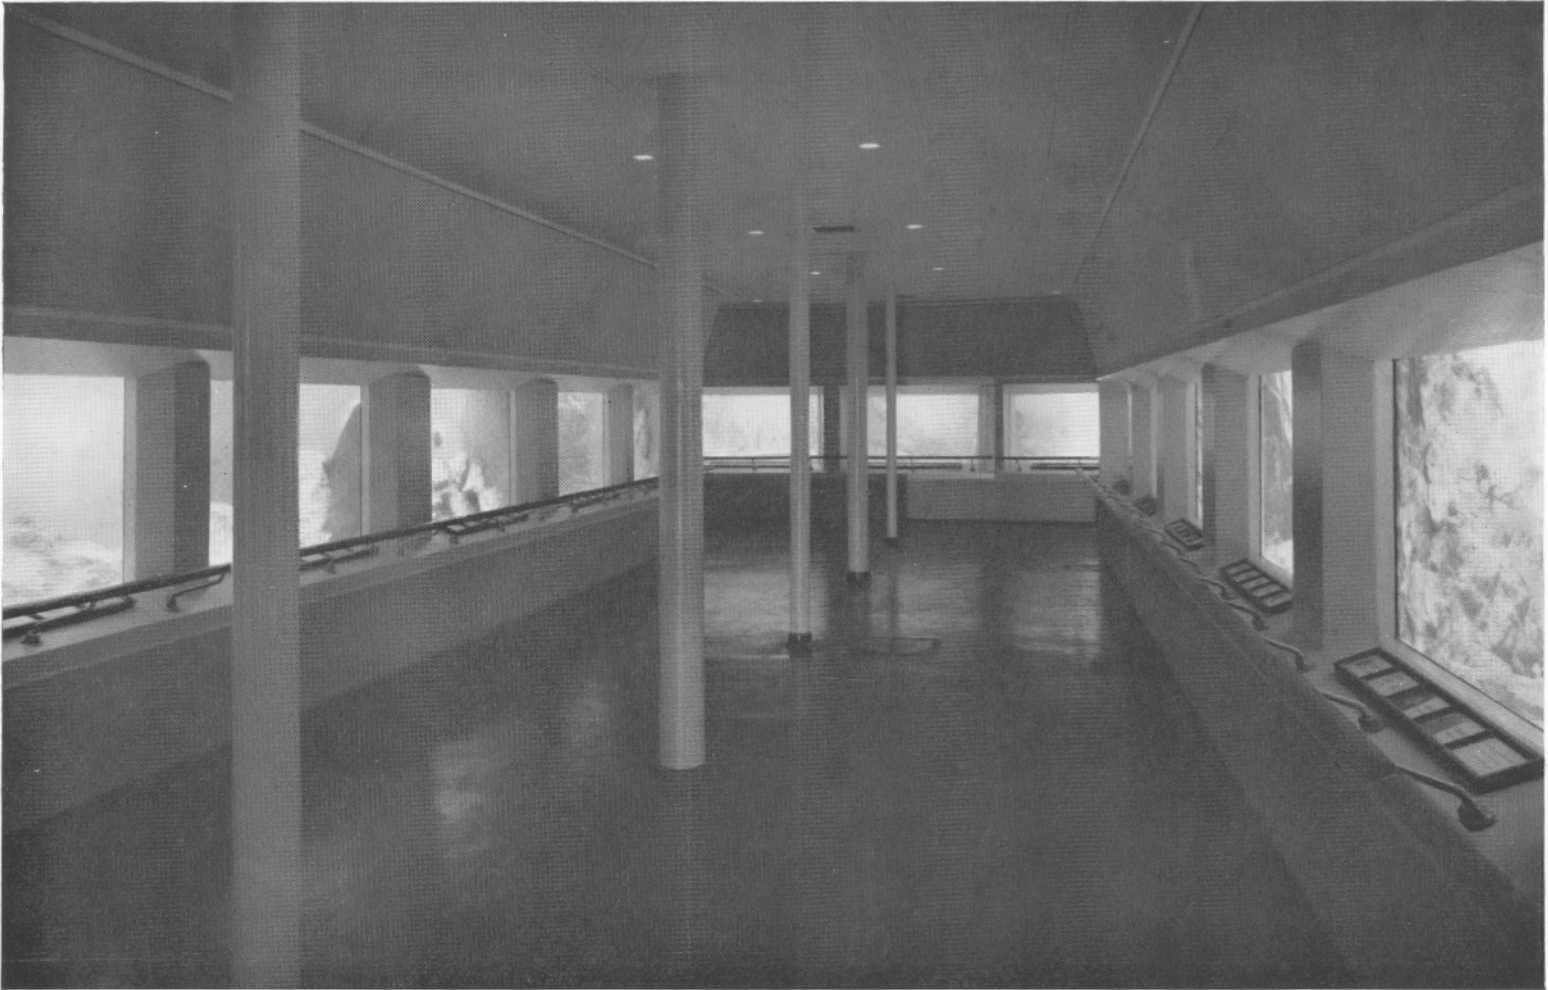
PLATE I

General view of the new aquarium from the public entrance lobby. Note the handrail, label frames, ceiling with inset lights, etc. (A photograph of the old aquarium from almost the same viewpoint is reproduced in Russell, 1948, pl. XXIII, fig. 1.)

On the sills in front of the tanks (Pl. I) frames of Afrormosia wood hold picture labels (lettered water-colour drawings sealed between Perspex). Each frame holds five labels which can be slid in from either end and screwed up against interference. A removable wooden hand-rail on iron supports inserted

The public hall (Pl. I) is lit mainly by light passing through the tanks aided by a series of recessed lights in the suspended ceiling. It is dim but not completely dark, there being sufficient illumination to see any object on the floor and to allow the Guide Book to be read.

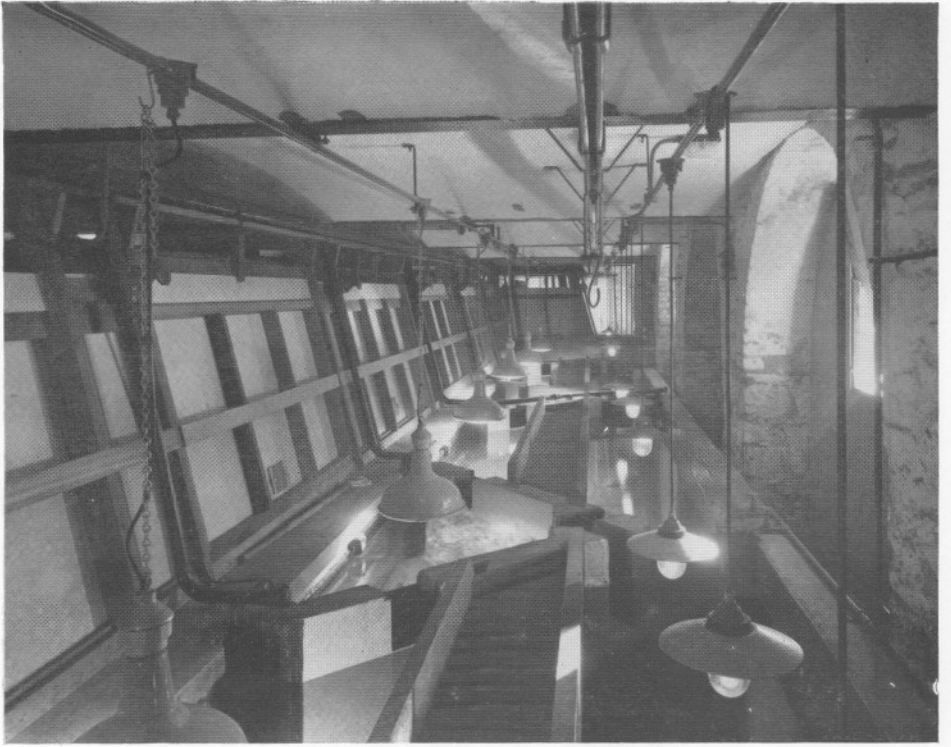
Fig. 1. View along the tops of the tanks of the south side from the west end. Note especially the shapes of the tanks, the lintel walk-way and cat-walks, the overhead conveyor track, details of inflows and overflows so far as visible, sea-water and compressed-air pipes (one of the latter on tank-back near right foreground), light fittings, etc. Compare especially with Text-figs. 4 and 5.

(Pl. II, fig. 1). Water is drawn in through holes near the bottom of the pipes or sheets and gushes out through slits slightly above water level. Experience and experiment in the old aquarium showed that such 'air-pipe pumps' use compressed air much more effectively than diffusers sited openly on tank floors.

Attached to the ceiling along most of the north side and the whole of the south, lengths of overhead track (Pl. II, fig. 1) provide convenient hand-rails above one edge of the cat-walks and serve for the easy transport of heavy objects.

walk and the backs of the tanks (Pl. II, fig. 1). At selected points screwed waterproof three-pin sockets are provided from which hang the lights, the heavier ones on chains. Over most tanks there is one main light (usually a 200 W., occasionally 100 W. bulb inside a watertight reflector fitting) 12 in. above water level and 12 in. from the top edge of each glass pane. The back lights are more numerous and more variable; they are mostly 100 W. bulbs in watertight fittings, but fluorescent tubes, protected from damp, are used in places. The back lighting has been arranged to give the most effective illumination of the rock scenery and therefore varies from tank to tank; the front lighting is more constant as it is intended mainly to illuminate the animals. The triangular tanks have only one light, the front one, but special effects can be arranged if needed. Front and back lights are independently fused and switched.

The angled-out side walls of the larger tanks are painted white (Pl. II, fig. 1), again with epoxy resins. This white surface is, of course, invisible to the public and it helps to reflect back into the tank some light which would otherwise be lost. To conceal the far corners of these tanks, with their inflows and swim-ways, rock cliffs are built against the side walls a little in front of them.

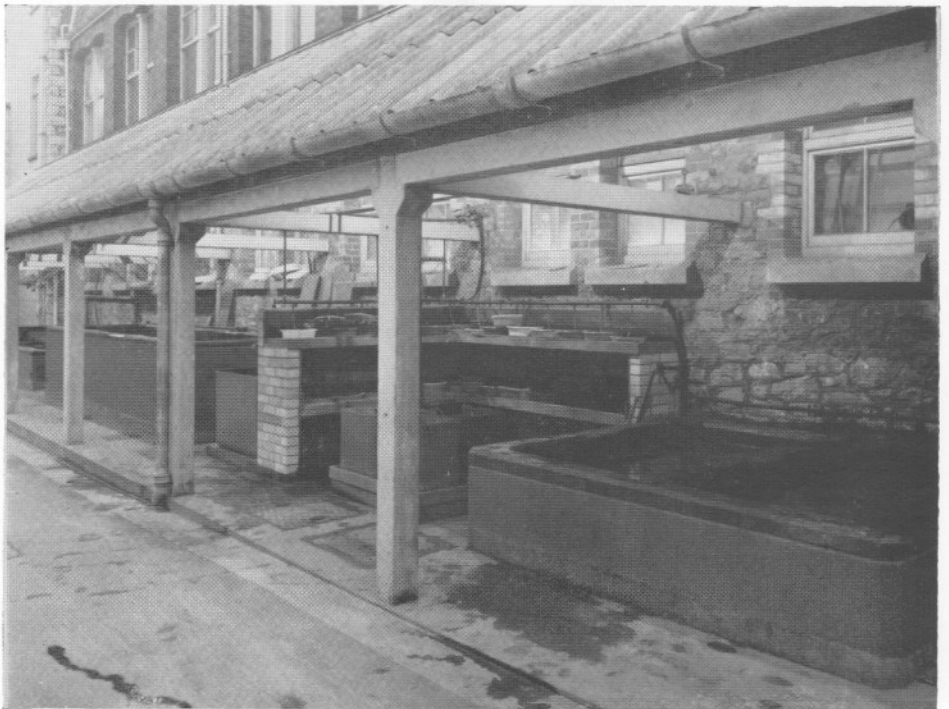
Fig. 2. View of new outside circulation tanks and circulation bench from the western end. Note in right foreground a pair of concrete tanks painted internally with black bitumen. Further on is the double-tiered circulation bench for bowls, and, in front, four small asbestos tanks on a low circulation table. Behind the circulation bench the outer of three large asbestos tanks, on a raised plinth, is seen. Farther on still is the large and deep concrete tank, then a pair of shallower concrete tanks similar to those in the foreground. Beyond these part of a row of three large asbestos tanks is just visible. (For photographs of the old outside circulation which these tanks replace see Russell, 1948, pl. XXII, fig. 2, and Wilson, 1952, text-fig. 4).
