Citizen Science Tools Reveal Changes in Estuarine Water Quality Following Demolition of Buildings

Keywords: water quality; mini Secchi disk; Vembanad Lake; demolition waste; citizen science

Citation: Menon, N.; George, G.; Ranith, R.; Sajin, V.; Murali, S.; Abdulaziz, A.; Brewin, R.J.W.; Sathyendranath, S. Citizen Science Tools Reveal Changes in Estuarine Water Quality Following Demolition of Buildings. *Remote Sens.* **2021**, *13*, 1683. <https://doi.org/10.3390/rs13091683>

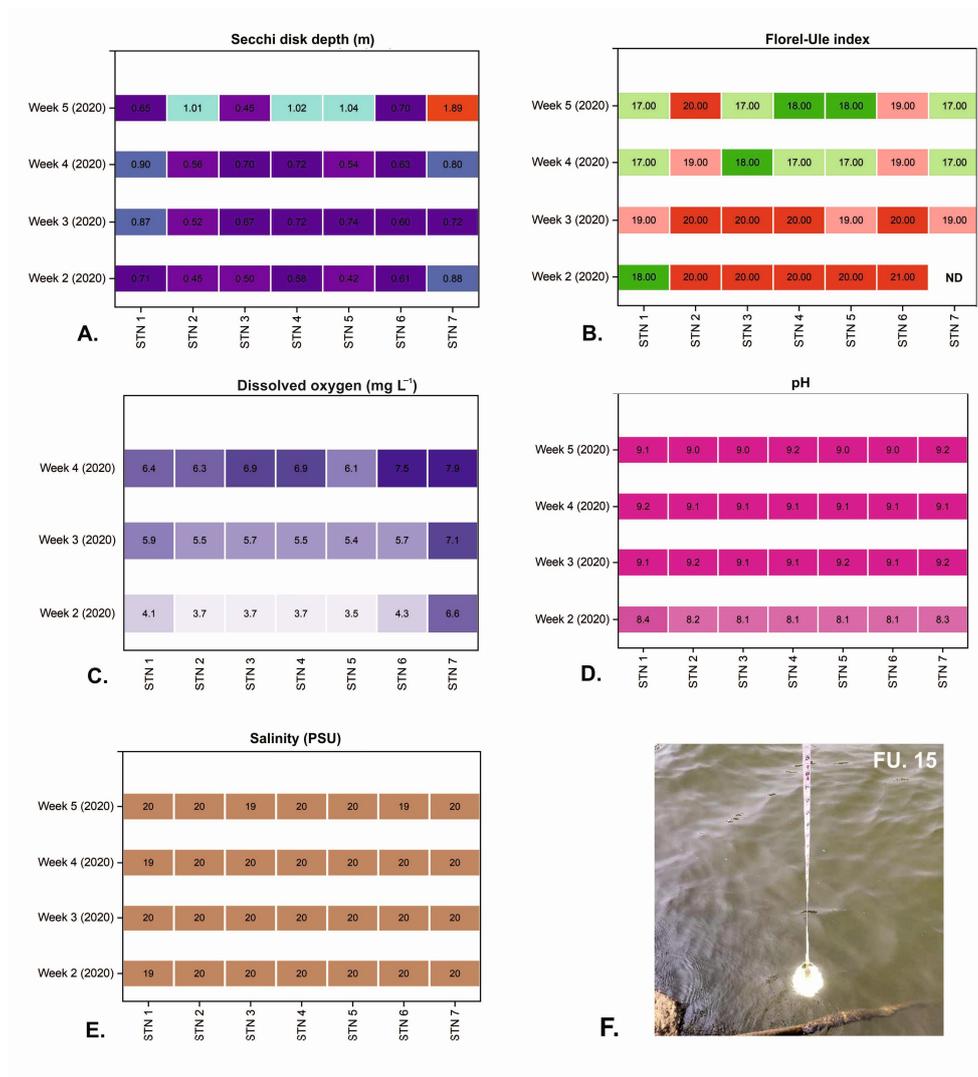
Figure 2. Variation in (A) Secchi depth (m), (B) water colour (Florel-Ule index), (C) DO (mg L⁻¹), (D) pH, and (E) salinity (psu) values at the 7 stations post demolition. (F) shows a sample photograph taken by citizen scientists of the water while operating the 3DMSD. ND—Not Determined.

Water was brown in colour (i.e., FU >18) as observed two weeks after demolition (Figure 2B). This colour was due to a high load of suspended particles in the water column. Similar colour indices had been previously detected in the Vembanad Lake only in June and were attributed to resuspension of sediment due to high mixing during the southwest monsoon, as well as to the transport of sediment-rich waters into the lake by the numerous rivers that discharge into the lake. With increasing duration after demolition, there was a general decrease in FU colour (17) at most stations, but it did not drop to 15 or below, i.e., green or blue colour indicating clearer waters, during the sampling period [16].

Salinity was found to be consistently high throughout the sampling in 2020 (19–20 psu) (Figure 2E), reflecting the samplings at high tide. There was no significant change in salinity from week two to week five after demolition (Table 1), suggesting little influence of other factors (e.g., precipitation or changes in tidal currents) on our findings.

The pH showed a steady increase in all stations from the second to the fifth week after demolition (Figure 2D). Significant increase in pH was evident during the third ($M = 9.11 \pm 0.04$, $p < 0.05$), fourth ($M = 9.1 \pm 0.05$, $p < 0.05$), and fifth ($M = 9.07 \pm 0.09$, $p < 0.05$) weeks compared with the second week ($M = 8.18 \pm 0.12$). It is known that cement effluents increase the alkalinity and pH of the receiving water [22]. The chemical composition of cement used for construction is comprised of calcium silicate hydrates, which include oxides of calcium (CaO) and silicon (SiO₂), with lesser amounts of aluminum oxide (Al₂O₃) and iron oxides (Fe₂O₃). These are subsequently polymerized into a densely-cross-linked matrix [23–25]. When brought into contact with water, the first hydration product capable of leaching from cement-based material is reported to be calcium hydroxide [24,25]. Addition of hydrated lime to water increases the pH of the system [26], and the rate of leaching increases with the surface area of the concrete in contact with water [25]. It has been reported that leaching of hydroxyl ions from cement increases with time and that the cumulative leaching rate is found to be higher in flowing water after three days and continues to increase over a further period of time [27,28]. This could be the reason for the sustained increase in the pH of the water even five weeks after demolition.

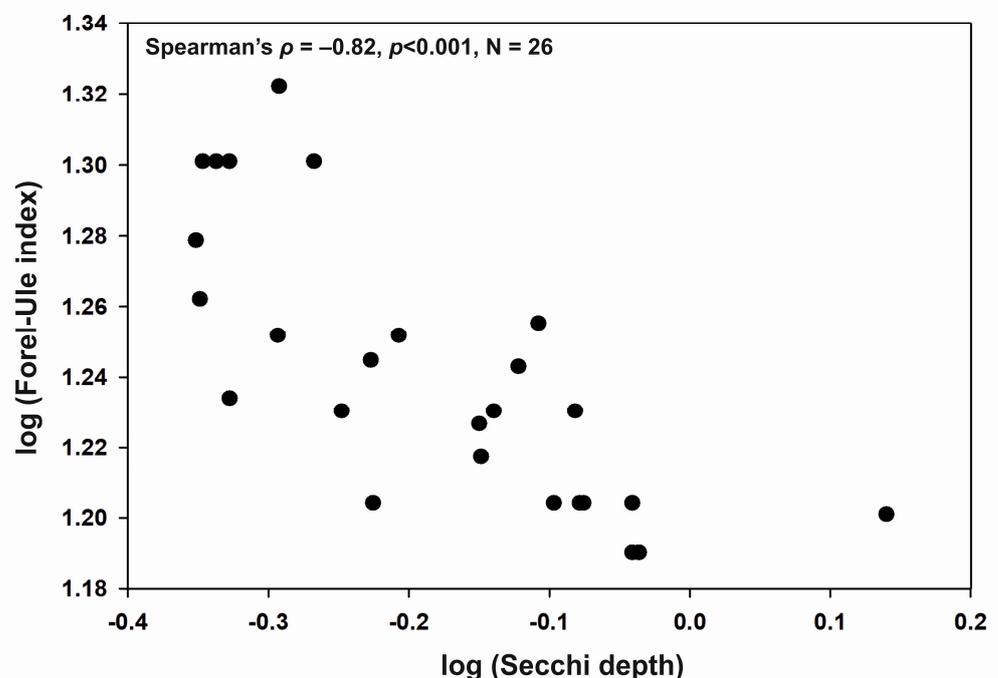
Figure 3. Spearman's rank correlation test statistics from weekly averaged FU Index and Secchi depth of the 7 stations during the 5 weeks after demolition. One outlier (−1.1 log SD and 1.26 log FU) was removed from the samples (N = 26).

Supporting the quality of our citizen observations, we observed a strong inverse relationship between the FU colour and Secchi depth (Figure 3). This is consistent with the finding of Garaba et al. (2015) [19] that the apparent colour darkens as water becomes muddier and turbidity increases with increasing suspended particulate and dissolved material (higher FU colour codes—brownish waters). A correlation test (Figure 3) helped in proving the utility of an inexpensive and simple technique and easy recording of readings in water quality assessment.

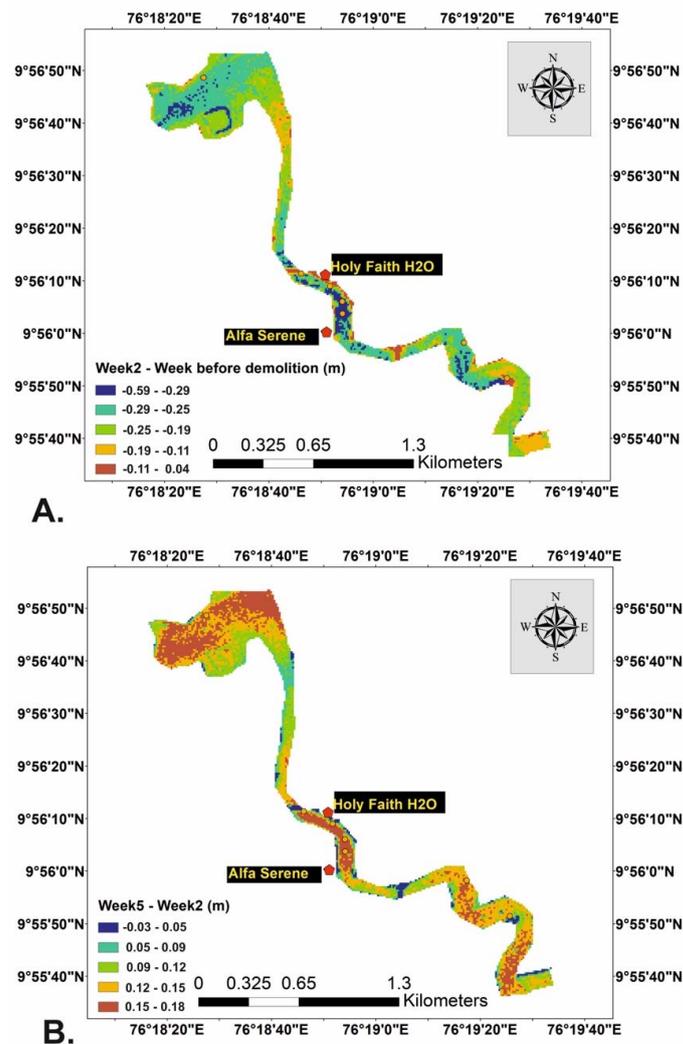
Figure 4. Difference in Secchi depth between weeks as derived from Sentinel 2A and 2B. (A) Second week after demolition—One week before demolition. (B) fifth week after demolition—second week after demolition.

Though the satellite observations yielded Secchi disk observations that were generally in the same range as the in situ observations, there was a systematic over-estimation of Secchi depth compared with the in situ observations when weekly averages were compared. This difference could have been for a number of reasons, including the use of weekly averages for the comparison, and the differences in the scales of observation, apart from the use of an algorithm that had been established for Portuguese waters. We therefore focused on relative changes observed in the satellite data. The comparison of the Secchi depth distribution during week 2 after demolition with that from the week before demolition exhibited significant reduction in Secchi depth by about 0.59 m along the demolition sites, owing to the increased turbidity from debris (Figure 4A). This information, which could not be obtained from in situ sampling, provides further evidence that the water body was exposed to decreased water clarity due to the demolition. Corroborating the in situ observation, an improvement in water quality was evident in the satellite derived

data also by the fifth week after demolition, with the Secchi depth at the demolition sites different by as much as 0.18 m compared with that of the second week (Figure 4B).

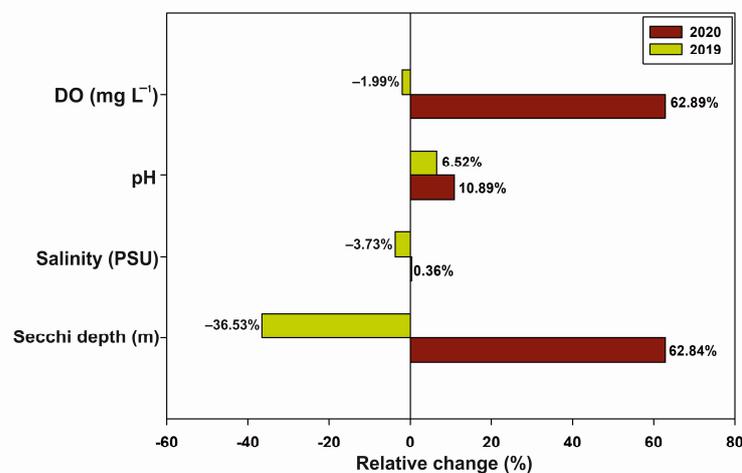
Figure 5. Percentage change in the variation of the water quality parameters in 2019 (pre-demolition) and 2020 (post demolition).

To examine if the changes in the environmental parameters were natural variations, data on the same variables during five weeks of same time period (January–February) in 2019 were subjected to paired *t*-test between weeks. However, none of the parameters (salinity, pH, DO, and Secchi depth) showed significant variation with time ($p > 0.05$) in the 2019 dataset. Relative variability in the observations in the two years (Figure 5) shows higher variability in 2020, especially with respect to DO (62.89% in 2020) and Secchi depth (62.84% in 2020). The small difference in the relative change in pH (10.9% in 2020 compared with 6.5% in 2019) may be misleading, as pH is based on a log scale, so even a small change can have enormous physiological ramifications. Such sudden fluctuations in pH of the system can affect the survival of estuarine organisms and hence the relative change is of high significance from the point of view of ecosystem health. SDG 14—life under the water emphasises that quality of water determines the life under water. The results bring to the fore the urgent need to shift to sustainable development pathways for the sustenance of the estuarine ecosystem.
